Debris/Ice/TPS Assessment and Integrated Photographic Analysis for Shuttle Mission STS-57

July 1993

Gregory N. Katnik
NASA/Kennedy Space Center

DEBRIS/ICE/TPS ASSESSMENT
AND
PHOTOGRAPHIC ANALYSIS
OF
SHUTTLE MISSION STS-57

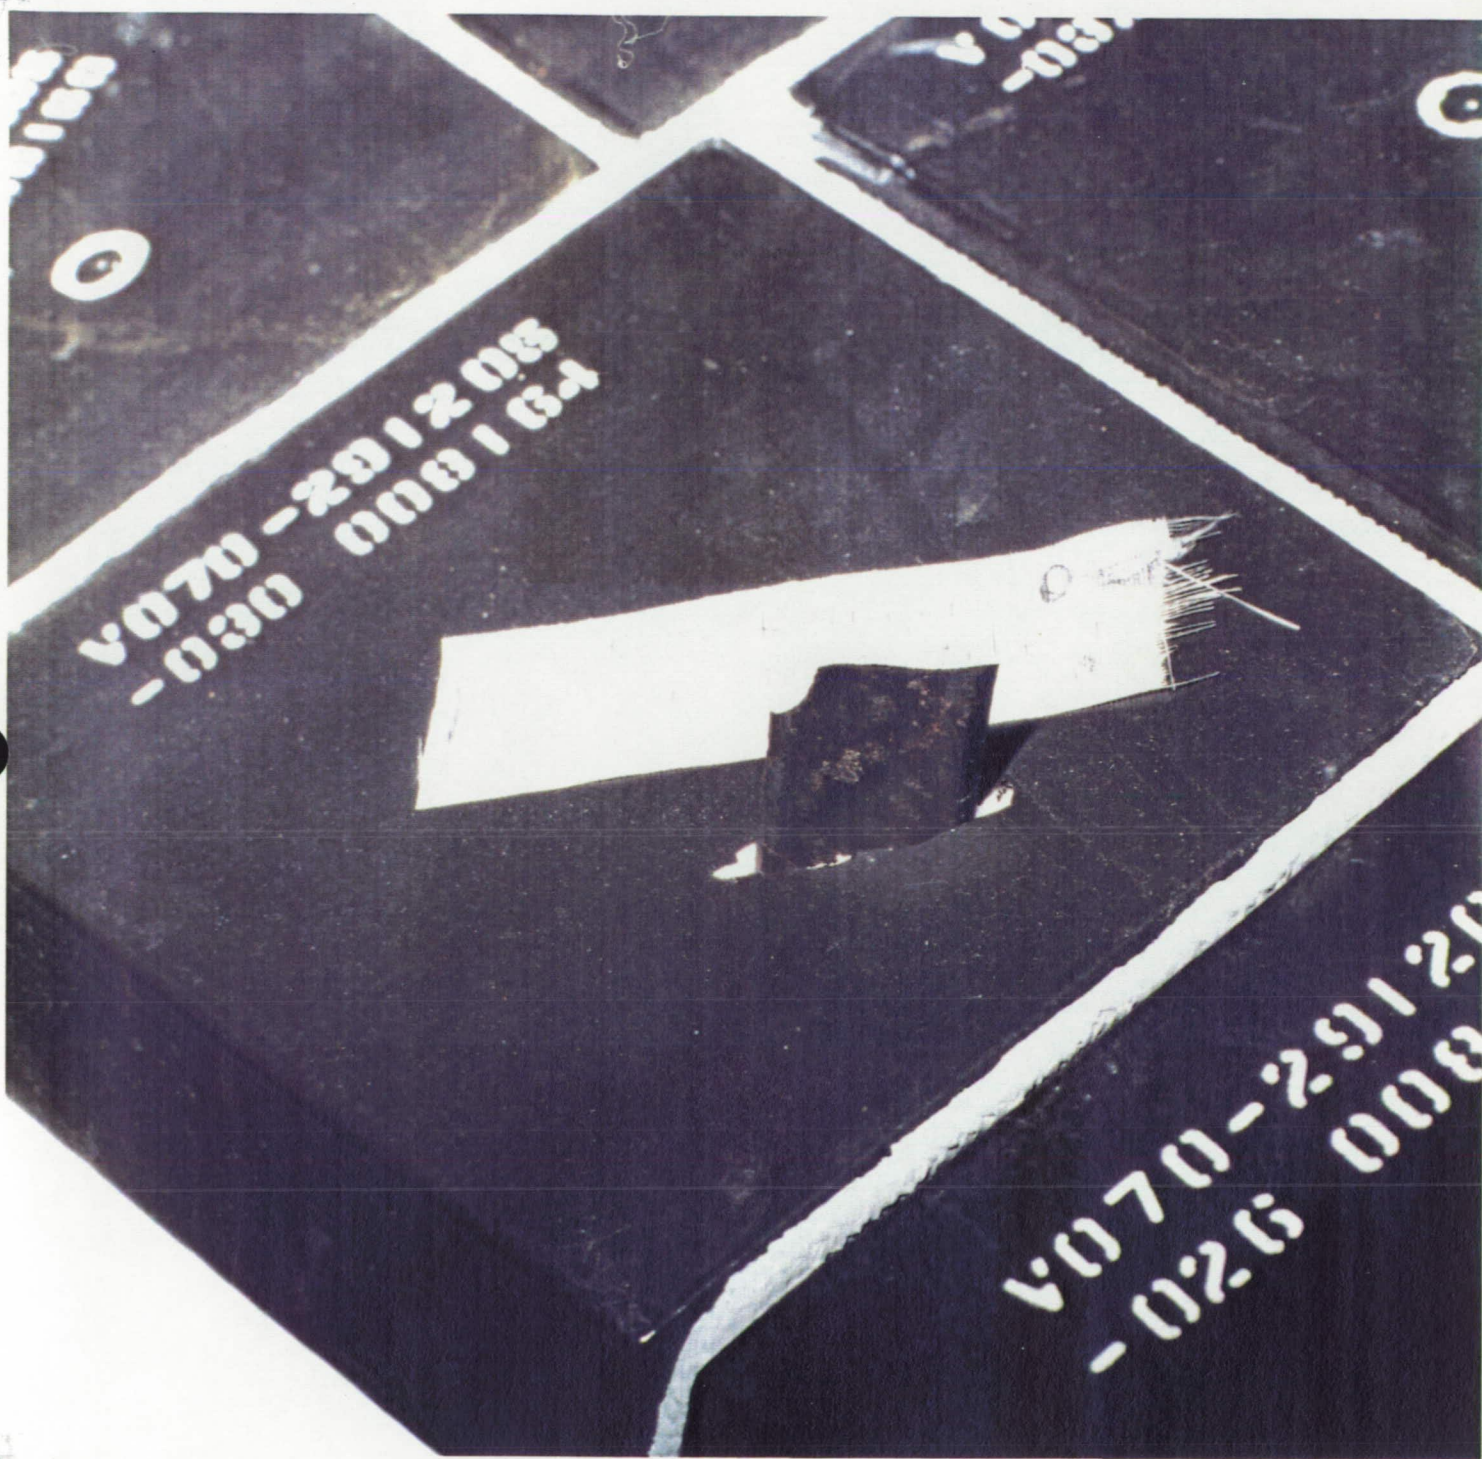
A 2" x 1" piece of metal spring was embedded in a tile
on the vertical stabilizer stinger near the hinge

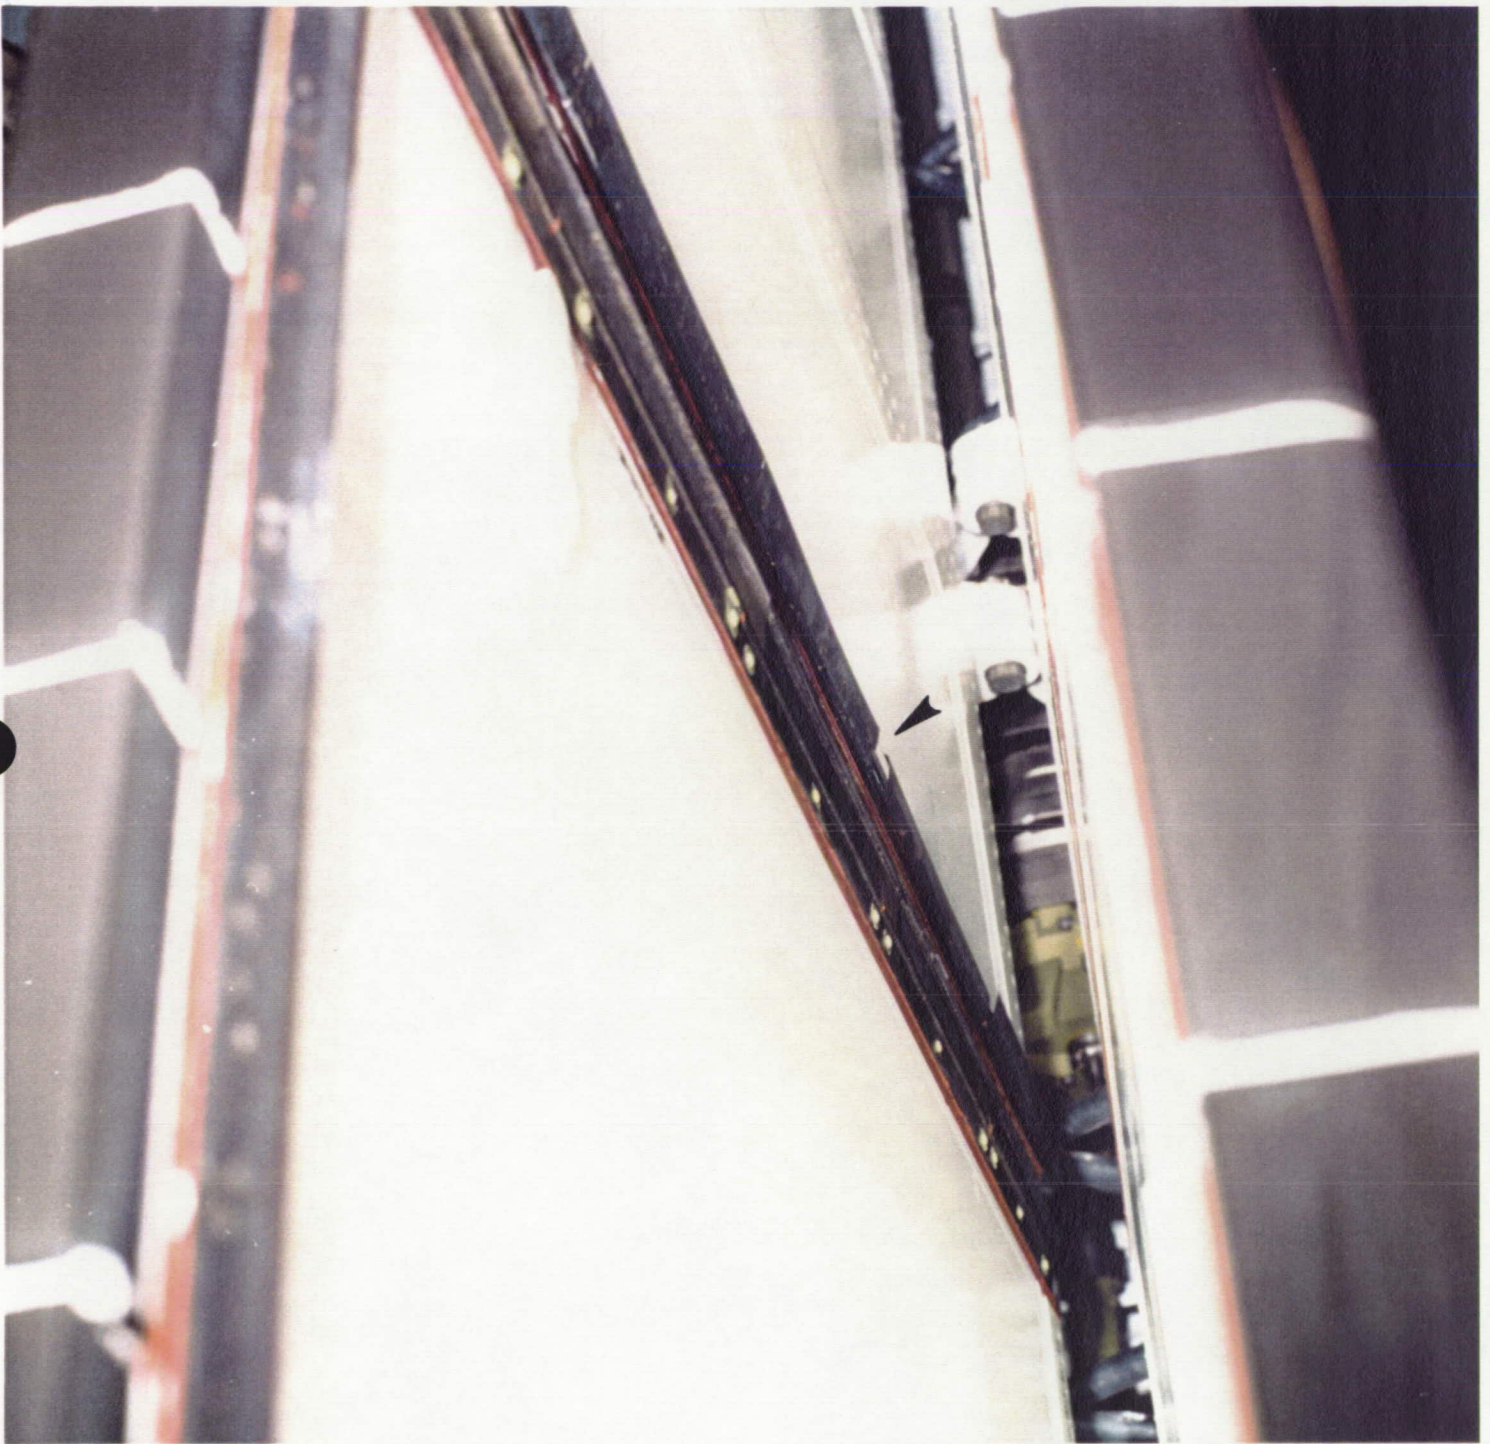
The piece of metal spring originated from the inside surface
of the rudder/speed brake left panel

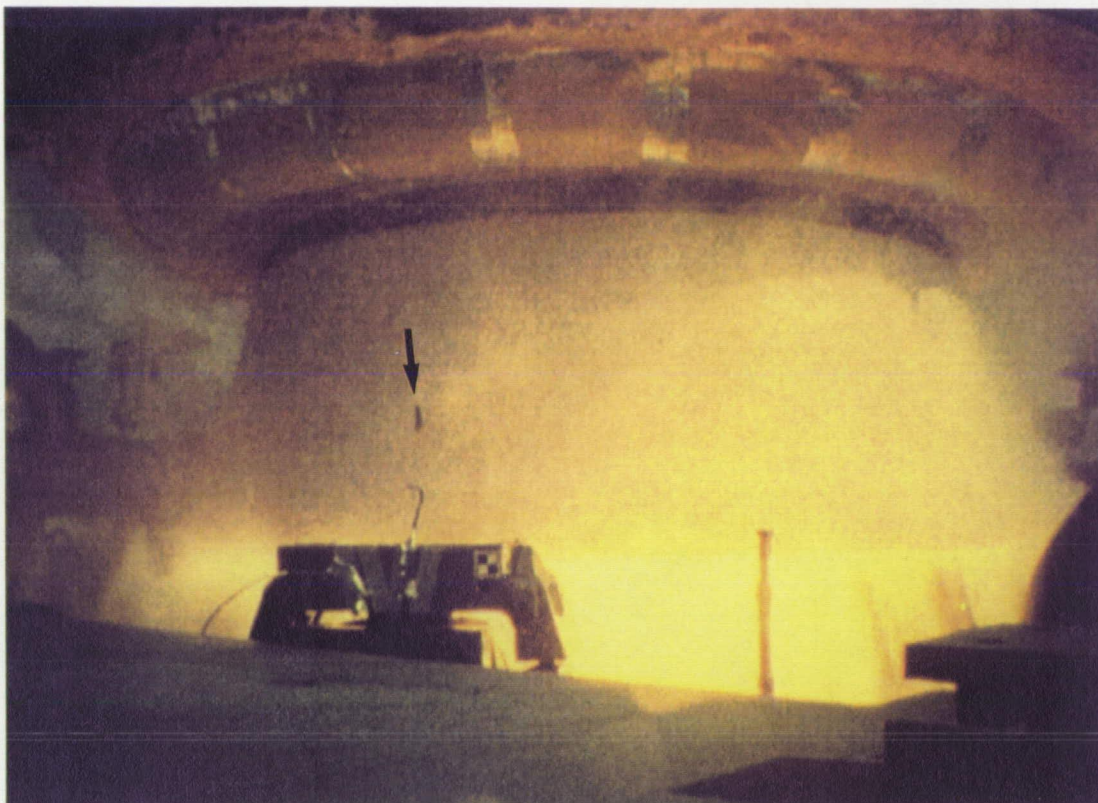
Figure 2.1.2.1 **Metallic Debris from DCS Stud Hole of the RSRB HDP M-2**

A metallic appearing piece of debris (see Figure 2.1.2.1) was noted to fall from the DCS stud hole of the RSRB holddown post M-2 at liftoff (13:07:23.048 UTC).

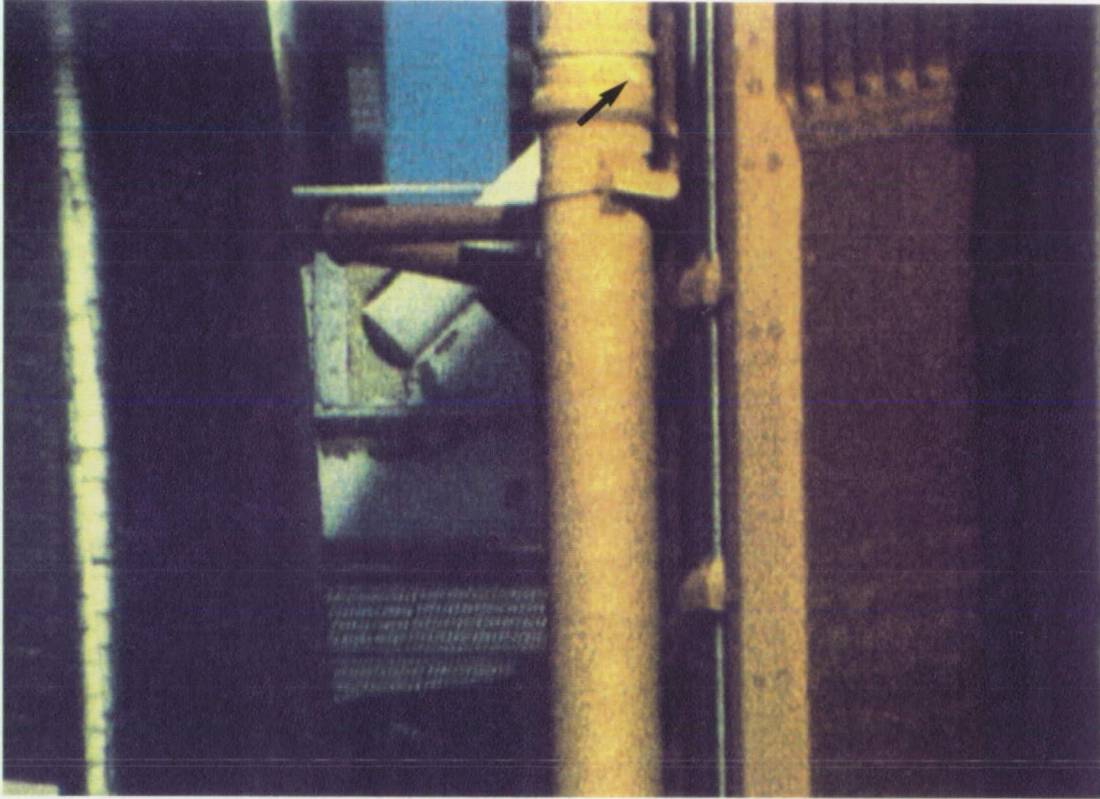
Figure 2.1.2.5 **Debris from LO2 Feedline Joint**

A white piece of debris (probably ice, approximately 3 inches in length) appeared to originate from the joint on the LO2 feedline near the forward bipod (see Figure 2.1.2.4) and fall along the LO2 feedline during liftoff on camera E-65. A smaller piece of debris was seen falling along the LO2 feedline at a lower location during liftoff on camera E-79. Neither debris item was seen to contact the vehicle.

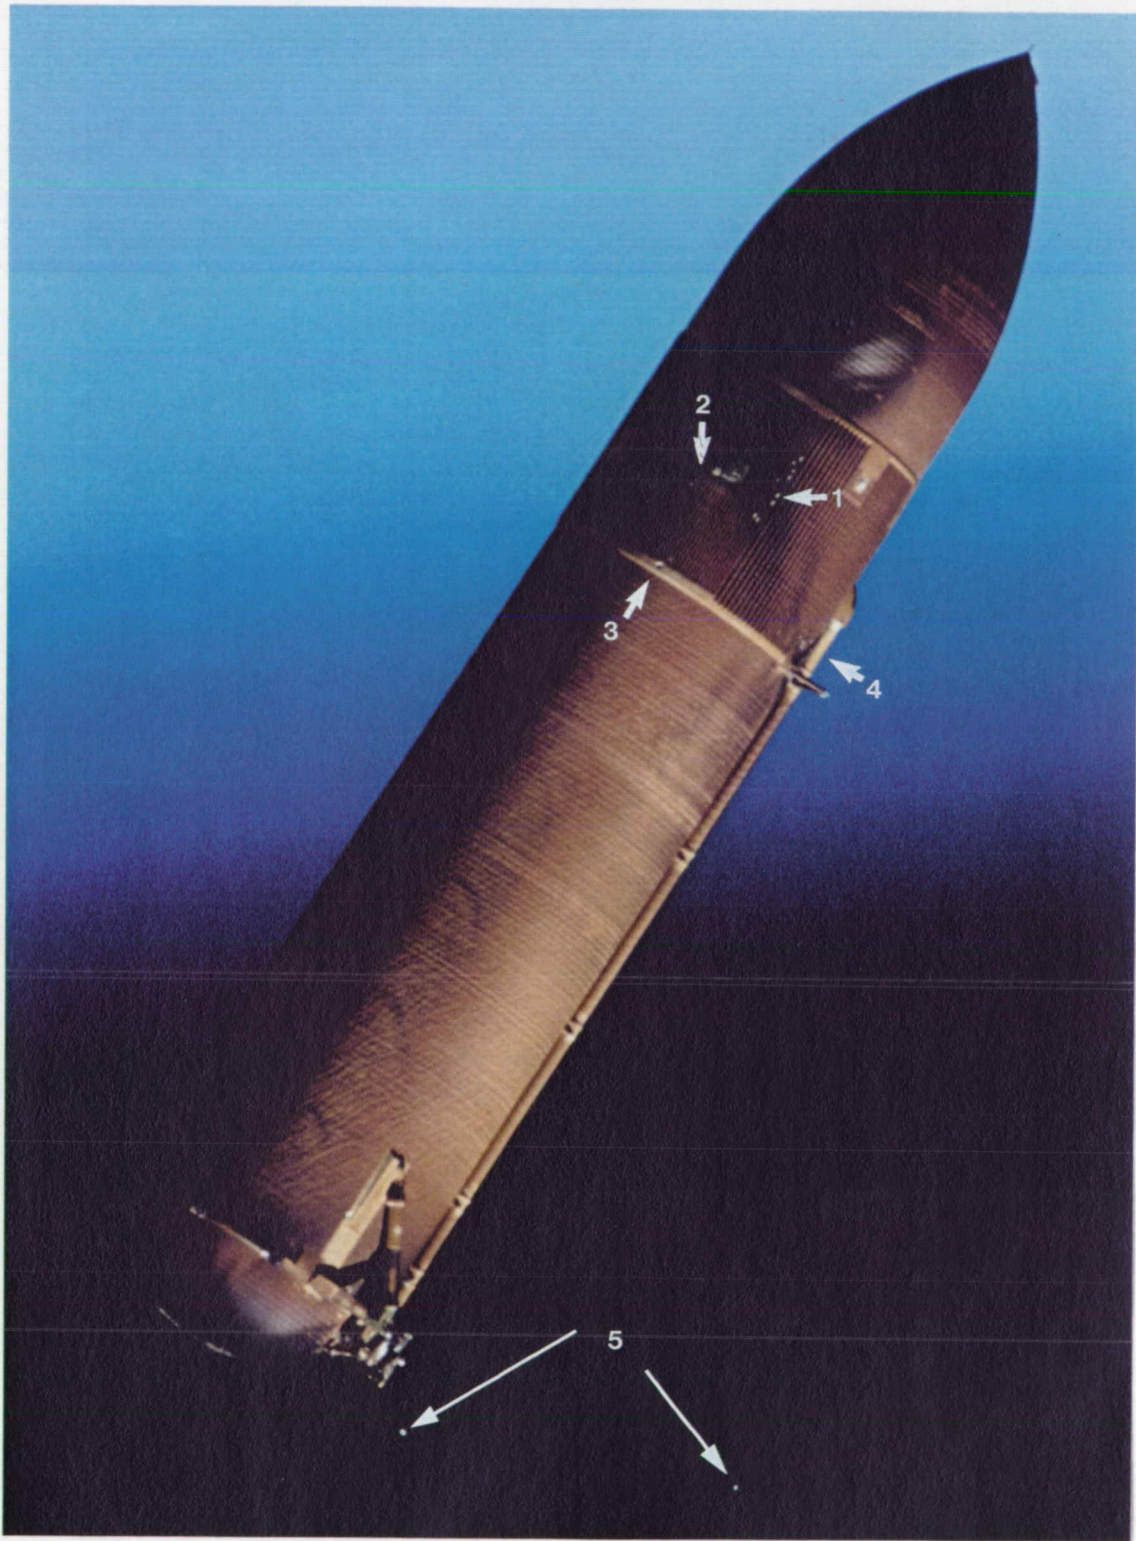
Figure 2.4.2 **Onboard Handheld Camera View of the ET**

Nine to ten divots were visible on the ET intertank TPS acreage to the right of the forward LSRB attach point (1). Five divots were visible on the LH2 intertank between the ET access door and the LSRB forward attach point (2). Two large divots were seen

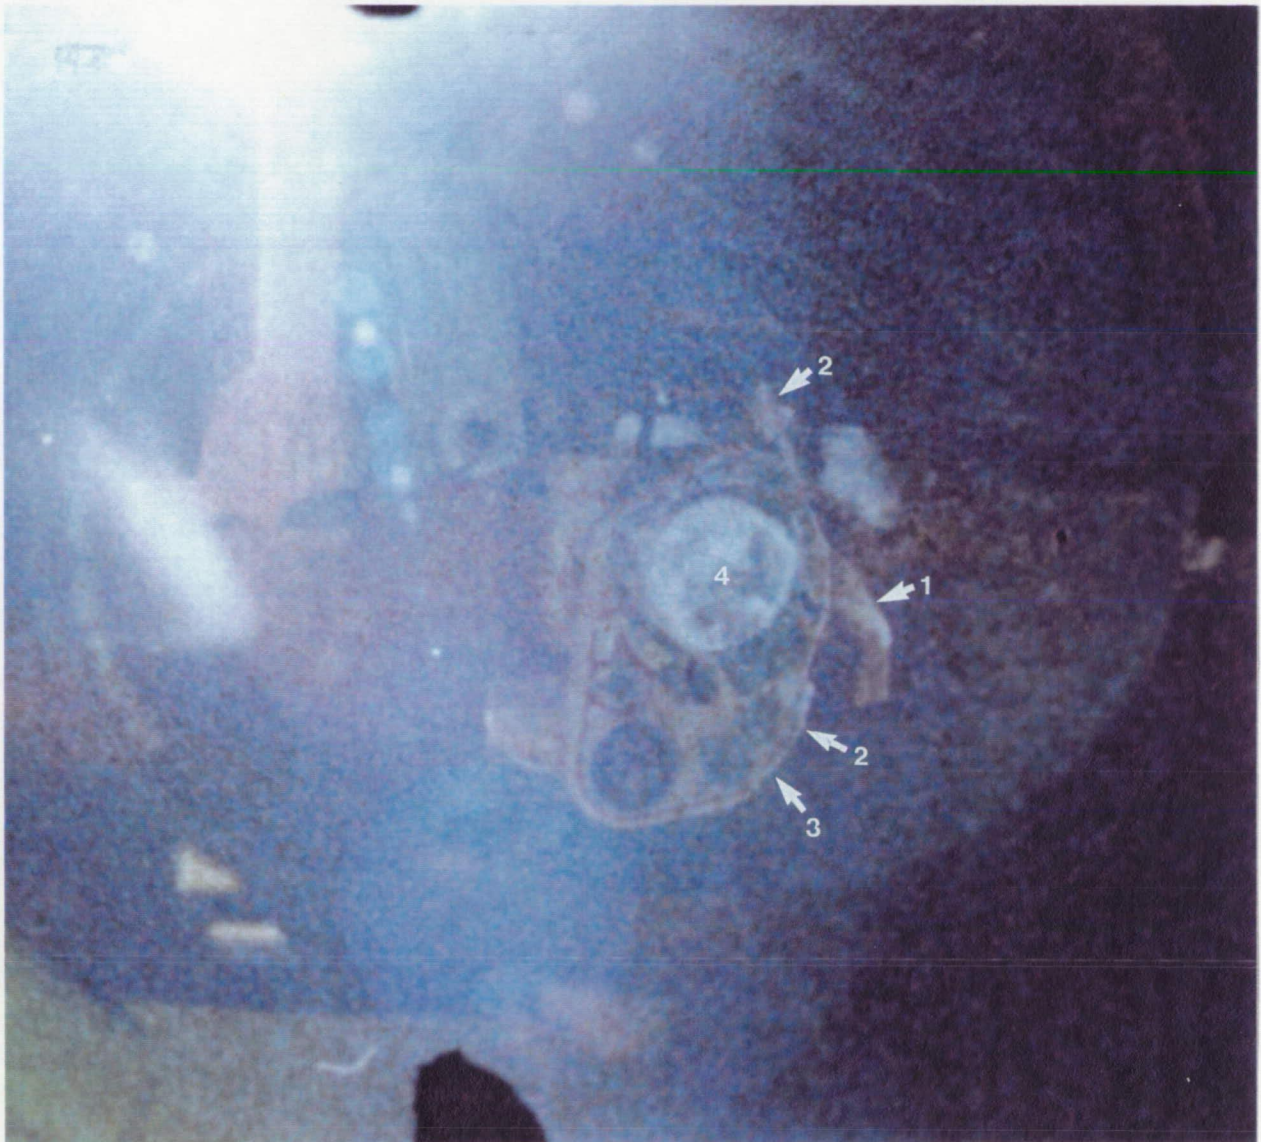
**Figure 2.4.3a****16 mm Camera View of the ET LH2 Umbilical**

A slender piece of white debris that appeared to be flexing was visible on the left side of the film view of the ET LH2 umbilical after ET separation. This may be a piece of white RTV that came from the LH2 umbilical.

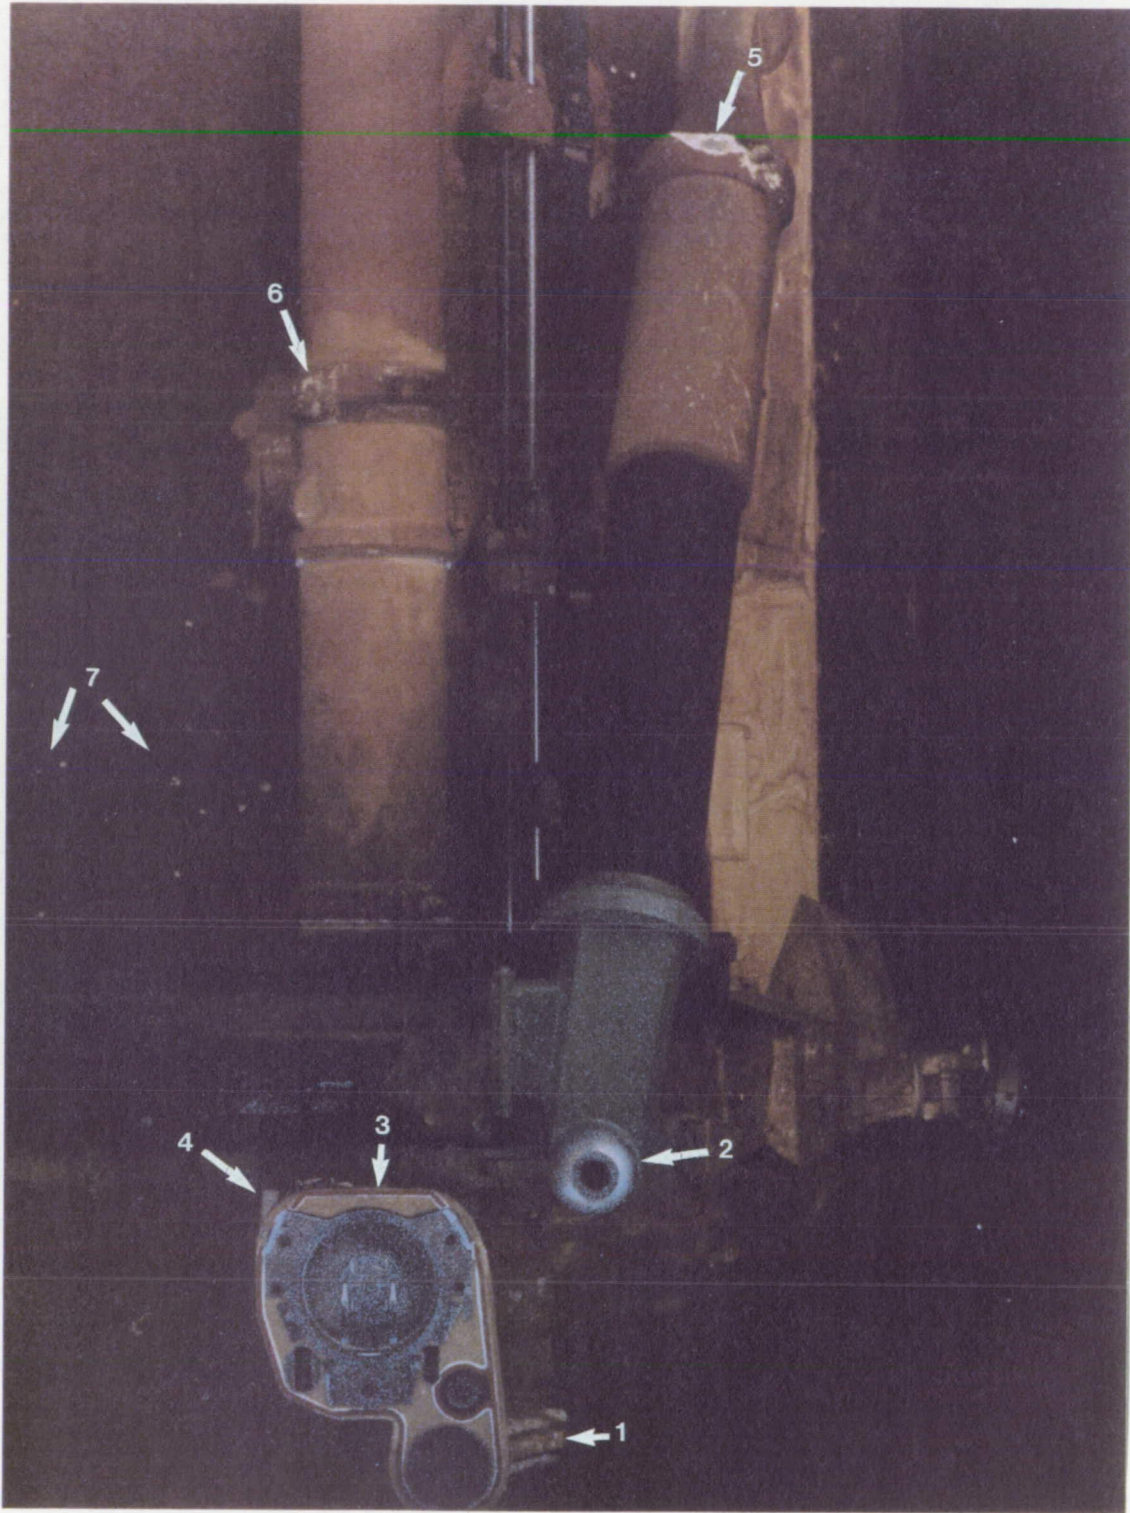
Figure 2.4.4a **35 mm Camera View of the ET LO2 Umbilical**

TPS erosion was visible on the right side of the LO2 umbilical (1). A red seal around the EO-3 fitting above the LO2 umbilical was detached (2). The lightning contact strip at the

forward end of the LO2 umbilical appeared to be missing (3). JSC engineers were consulted and according to their information the electric contact strip was present prior to launch. Possible TPS damage or a piece of loose insulation was visible near the upper left corner of the LO2 umbilical (4). This possible loose insulation may be related to a three inch piece of ET foam that was found during the post landing inspection of the Orbiter LO2 umbilical by the debris inspection team. This three inch piece of foam adhered to a tile on the LO2 door near the hinge line according to the post landing inspection team report. A section of TPS was missing from the forward end of the ET aft +Y LO2 vertical thrust strut (5). The missing TPS appeared to have left a deep divot. A primed or bare metal surface was visible at the center of the missing TPS area. An engineer at MSFC stated that the missing TPS is being worked as part of the divot problem reported on the STS-56 external tank (inflight anomaly number STS-56-T-001). TPS erosion was visible on a aft bracket over the LO2 feedline at approximately station 1958 (6). Small, white marks were visible on the TPS to the left of the LO2 feedline at the base of the LH2 tank (7).

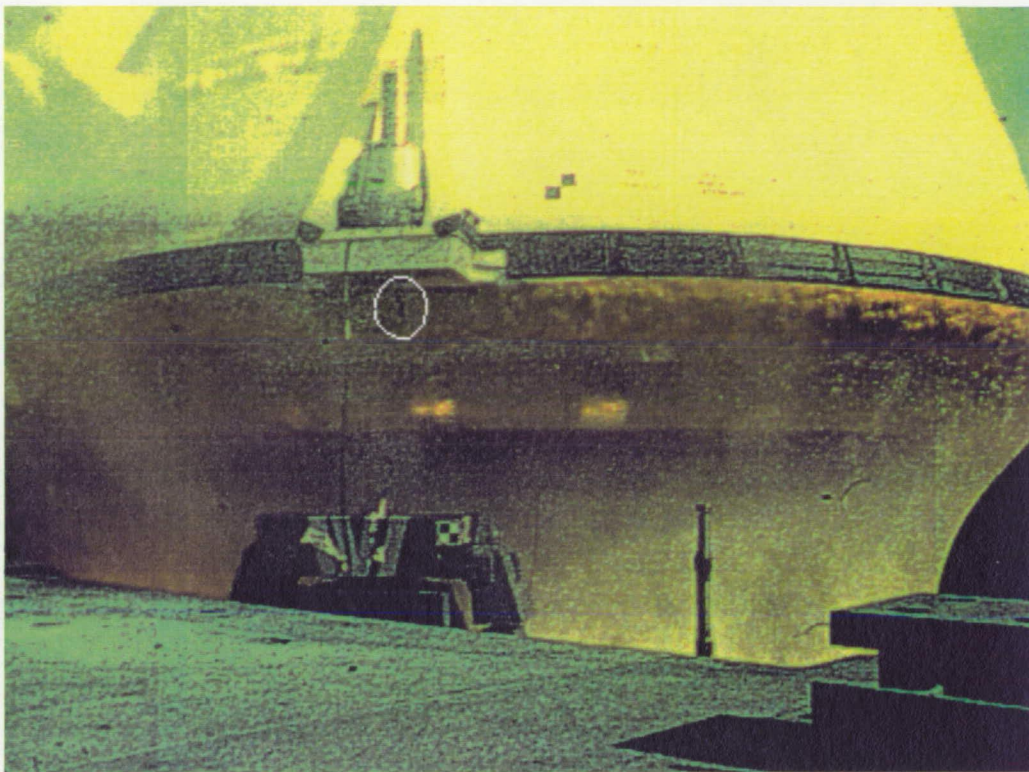
Figure 1.

Frangible nut material from holddown post M-2.

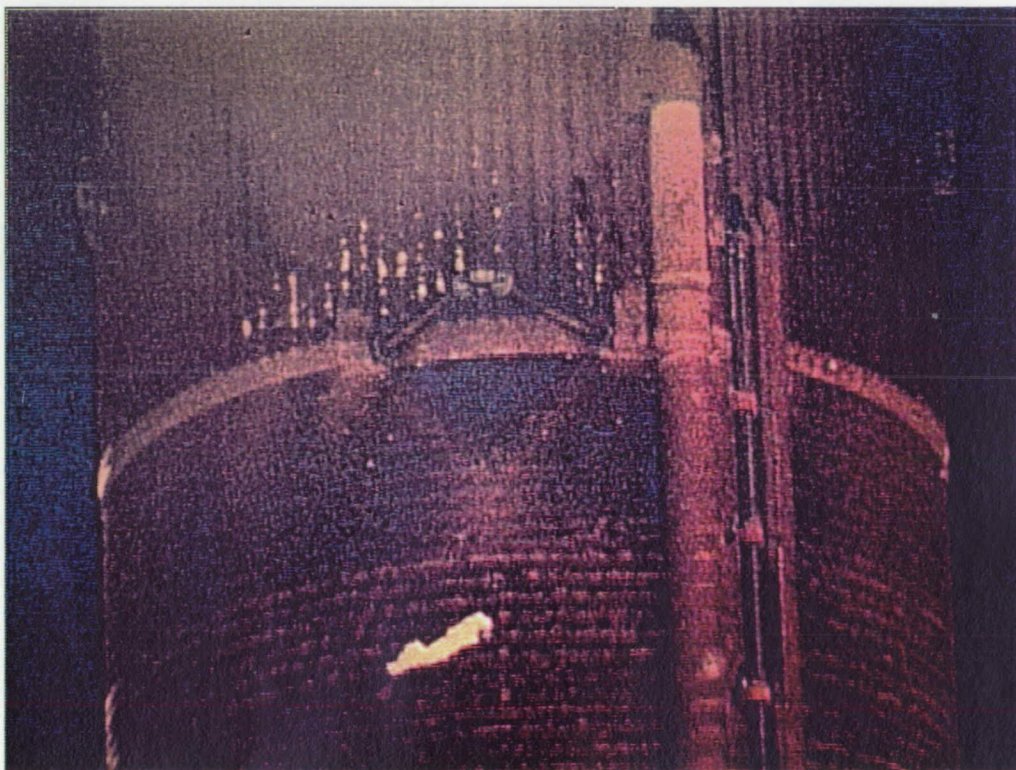
Figure 2.

Popcorning of TPS near bipod strut and large divot on LH2 tank.

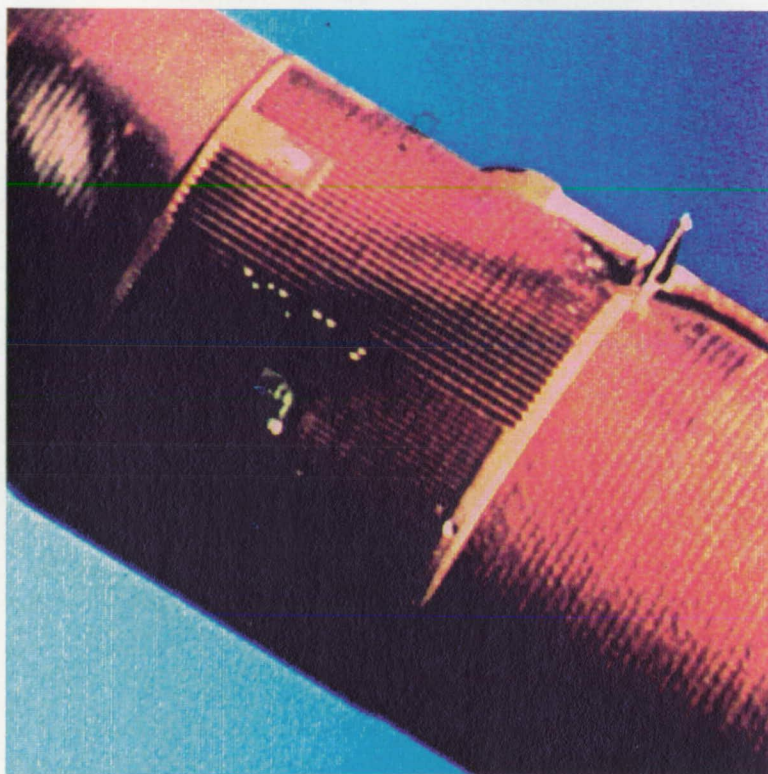
Figure 3.

Divots on intertank near left SRB attach point.

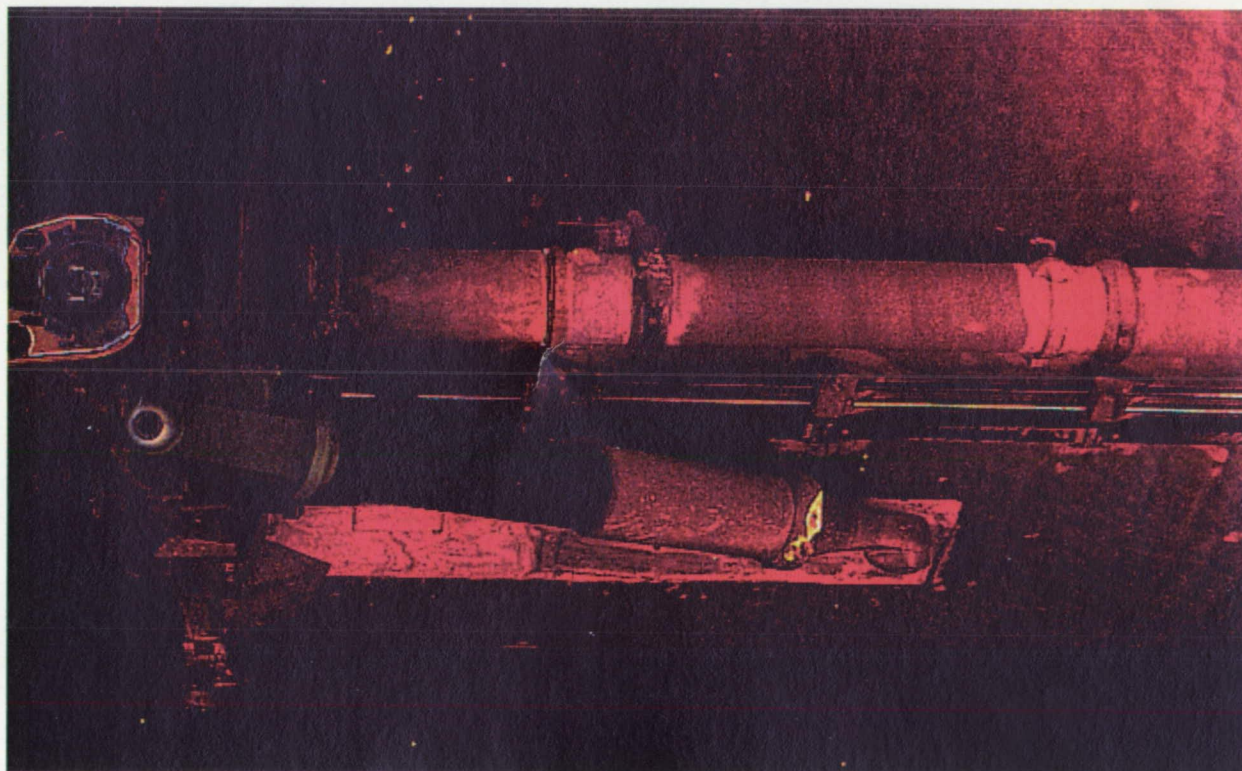
Figure 4.

Divots on thrust strut.
